# CONSERVATION NEWS

**WINTER 2021**

## CONSERVATION ASSISTANCE AT FOOD BANK OF DELAWARE FARM

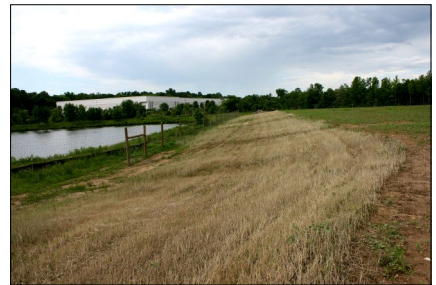
Erosion control work in 2018

- ◆ Erosion control on slope adjacent to existing stormwater pond
- ◆ Cover crop planting to improve soil health and stop erosion
- ◆ Drainage improvements including a drainage tile system around the hoop houses to the stormwater pond. Water run-off from the plastic hoop houses was seeping into the hoop houses saturating the soil where the crops were growing. The newly installed drainage system captures that water and takes it to the stormwater pond which provides a much better growing environment for the crops in the hoop houses and a nicer place for the volunteers and employees to work.

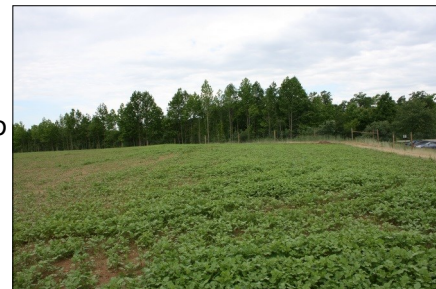
First cover crop in 2018

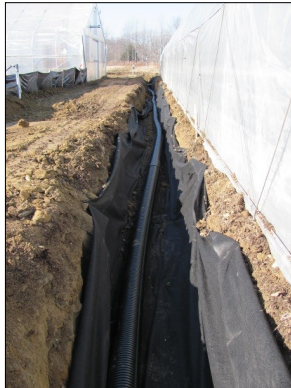
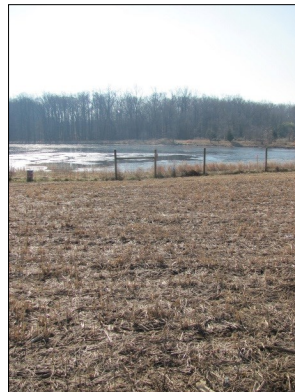
A drainage system was installed along both sides of the two existing hoop houses. A third hoop house is planned for the future. The black plastic perforated pipe is wrapped in fabric and then covered with stone and finally soil. The system is sloped to drain the water to the stormwater pond located down slope from the hoop houses.
